AVIATION INVESTIGATION REPORT

A01H0002

LOSS OF SEPARATION

NAV CANADA
GANDER AREA CONTROL CENTRE
SYDNEY, NOVA SCOTIA, 23 NM SE
05 MARCH 2001

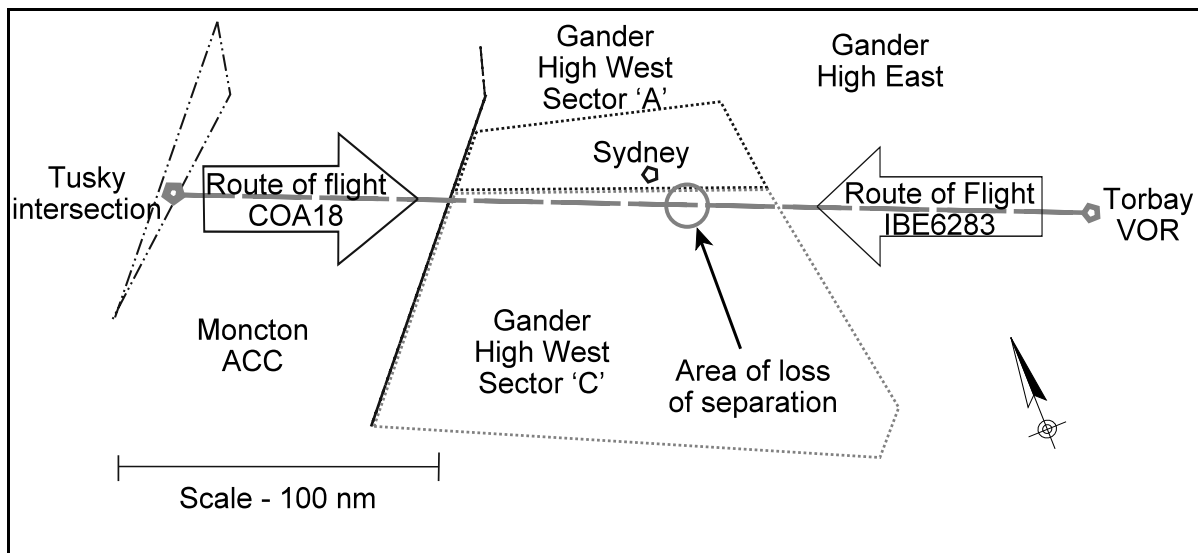
Figure 1 - Route of Flight

COA18 had been cleared at flight level (FL) 330 through Moncton and Gander Area Control Centre (ACC) controlled airspace on an eastbound route from TUSKY intersection to Torbay VOR (very high frequency omnidirectional RADIO range) navigation aid before entering oceanic airspace. (see Figure 1.) When the Moncton ACC controller solicited a ride report from COA18, the crew advised that they were experiencing continuous light turbulence (chop). Ten minutes later, COA18 advised that the flight was now in continuous light chop, with occasional moderate chop. Based on previous reports of a smoother ride at FL350, the controller offered that altitude to COA18 with a turn off course to accommodate traffic. COA18 requested to maintain its present course at FL330 until clear of conflicting traffic. At 1339:03 Newfoundland standard time (NST)¹ the Moncton ACC controller cleared COA18 to climb to FL350. The change in altitude was not passed to Gander ACC immediately, nor did the Gander/Moncton Agreement specifically require controllers to do so. FL350 was not an appropriate altitude for the direction of flight. Controllers use the term “wrong way” for internal communications with other air traffic control (ATC) sectors to describe this situation.
